# Manhole Inspection Summary

Manhole # S05EE2015MH

**Location** Address: **2814 W STRATHMORE AVE** Cross Street: **WOODCREST AVE**

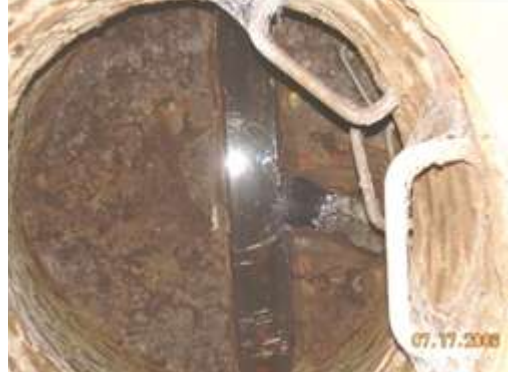
Top View

Adjustment, Corbel, and Barrel infiltration.  
Evidence of surcharge - Bench debris.  
Channel debris.

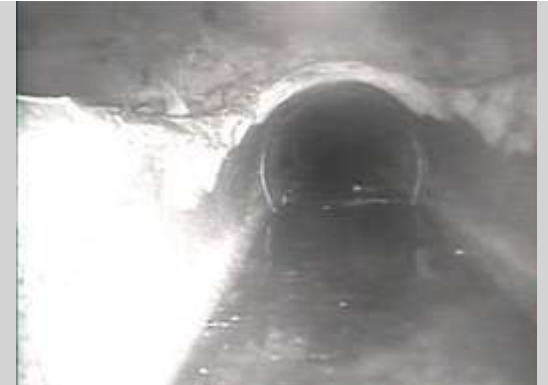
### 8 in. Circular Gravity Sewer Pipe Out @ 12 O'Clock

Invert Depth: **8.80** (ft.) Flow Characteristics: **None**

Deposits: ☒ None ☐ Mud ☐ Sludge ☐ Debris ☐ Grease

Infiltration: **None** Pipe Seal Cond: **Unknown**

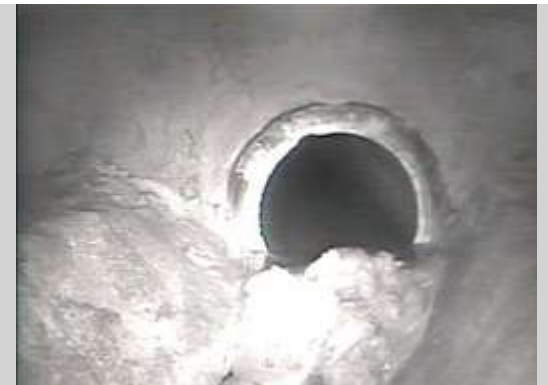
### 6 in. Circular Gravity Sewer Pipe In @ 3 O'Clock

Invert Depth: **8.50** (ft.) Flow Characteristics: **Slow**

Deposits: ☐ None ☐ Mud ☐ Sludge ☒ **Debris** ☐ Grease

Silt Depth: **1** (in.) Deposits Extent: **Light**

Infiltration: **Evidence** Pipe Seal Cond: **Unknown**

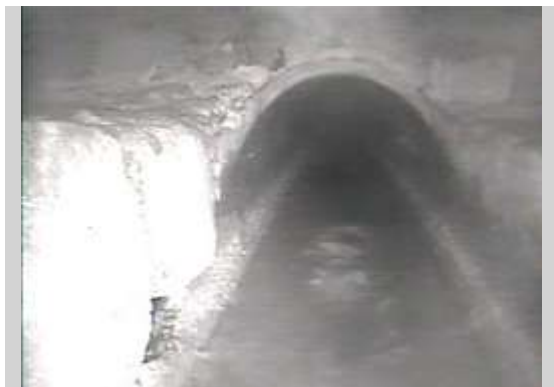
8 in. Circular Gravity Sewer

Infiltration: **Evidence**

Pipe Seal Cond: **Cracked**
